Introduction

There are many variables involved in the design and construction of a radio communications system. One in particular that becomes extremely difficult to troubleshoot is Passive Modulation (PIM). This application note will give you tips on what to look for when experiencing problems in your radio communications system.

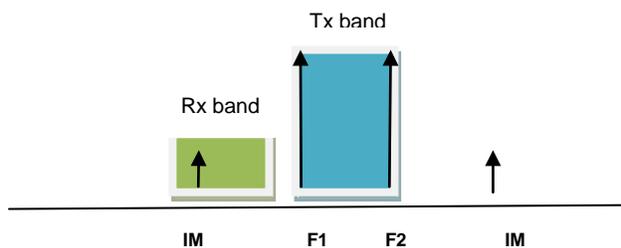
Figure 2

Examples include particles from machining operations or soldering splatters that touch current carrying surfaces, separation of current carrying contact zones through irregular contact surfaces, corrosion and insufficient contact pressure, and dissimilar metals at contact areas. Insufficient thickness of plated metal causing RF heating through the skin effect of RF, and bad solder joints are possible sources for PIM increase, see Figure 2.

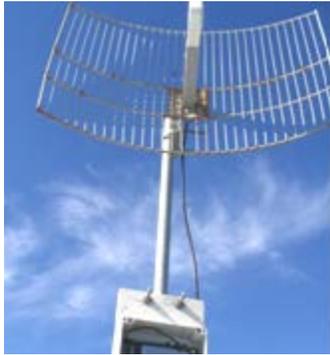
Figure 3

Antenna elements, for example, should be inspected for signs of corrosion, see Figure 3. Where blemish of the surface metal is evident, replacement is recommended. Far field performance for antennas on a site should be measured every two to three years, and compared to gain and radiation pattern measurements recorded at installation. Any antenna showing substantial deviation should then be further examined to determine the cause.
